APPENDIX C

NOISE MONITORING SHEETS

Project Number: OWR2001
Project Name: Prima Deshecha
Test Personnel: Corey Knips

Noise Measurement Survey

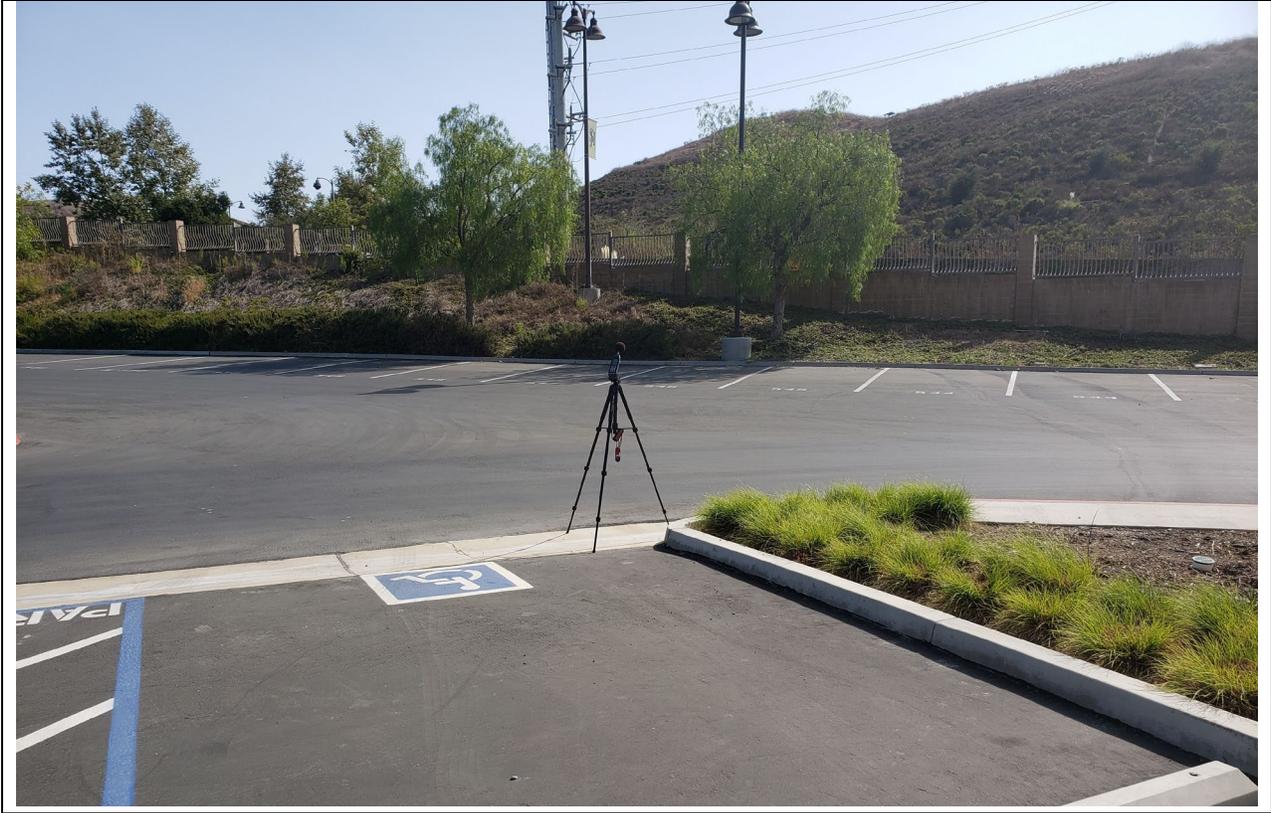
Location Photo:

Site Location: San Juan Hills High School, 29211 Stallion Ridge, San Juan Capistrano. In the parking lot 30 feet south of Building J.

Primary Noise Sources: Very light traffic on Stallion Ridge and a clanking noise at the transmission line poles near the corner of Via Zamora and Via Pamplona (for long periods at a time throughout the measurement).

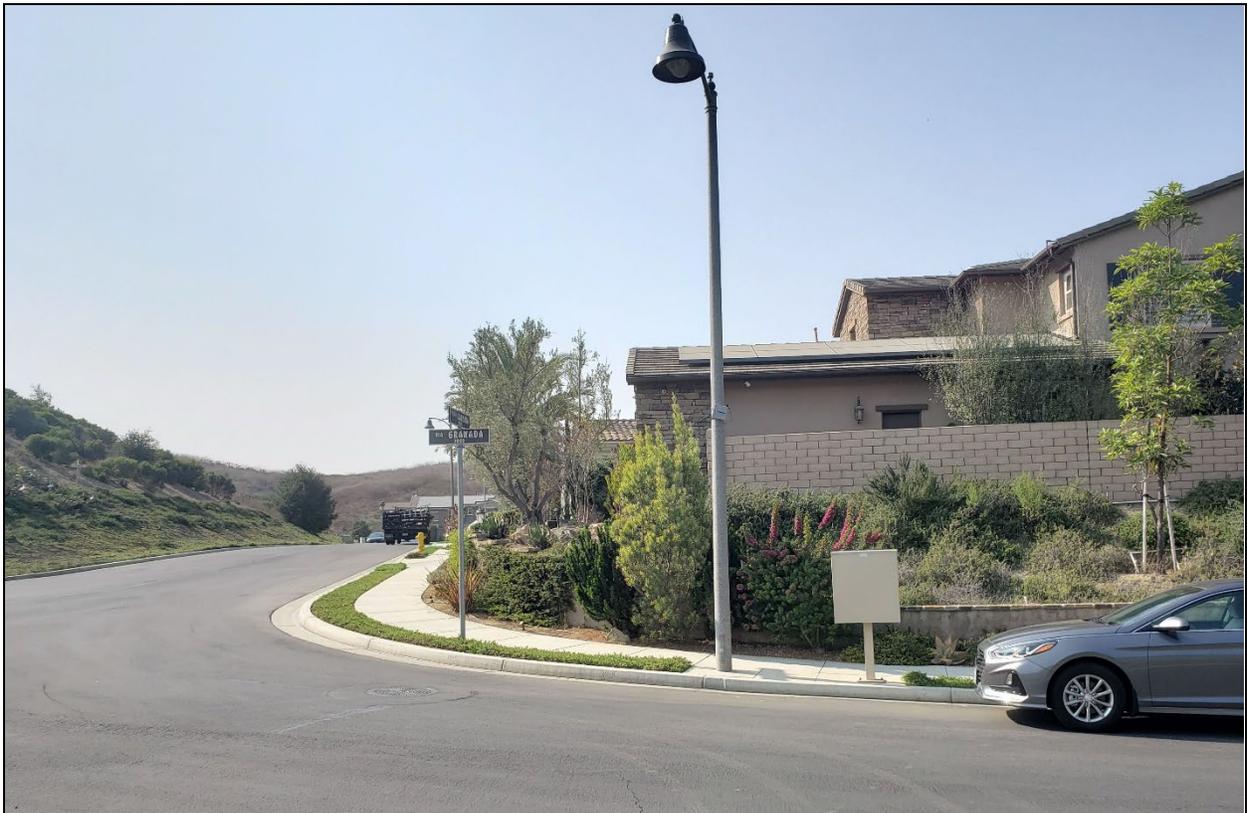
Location Photo:

Site Location: Corner of Via Granada and Paseo Carmona, on light pole.

Primary Noise Sources: Very quiet, occasional car driving by on Via Granada/Paseo Carmona. There was a dog at the nearest residence that barked when the dosimeter was picked up.

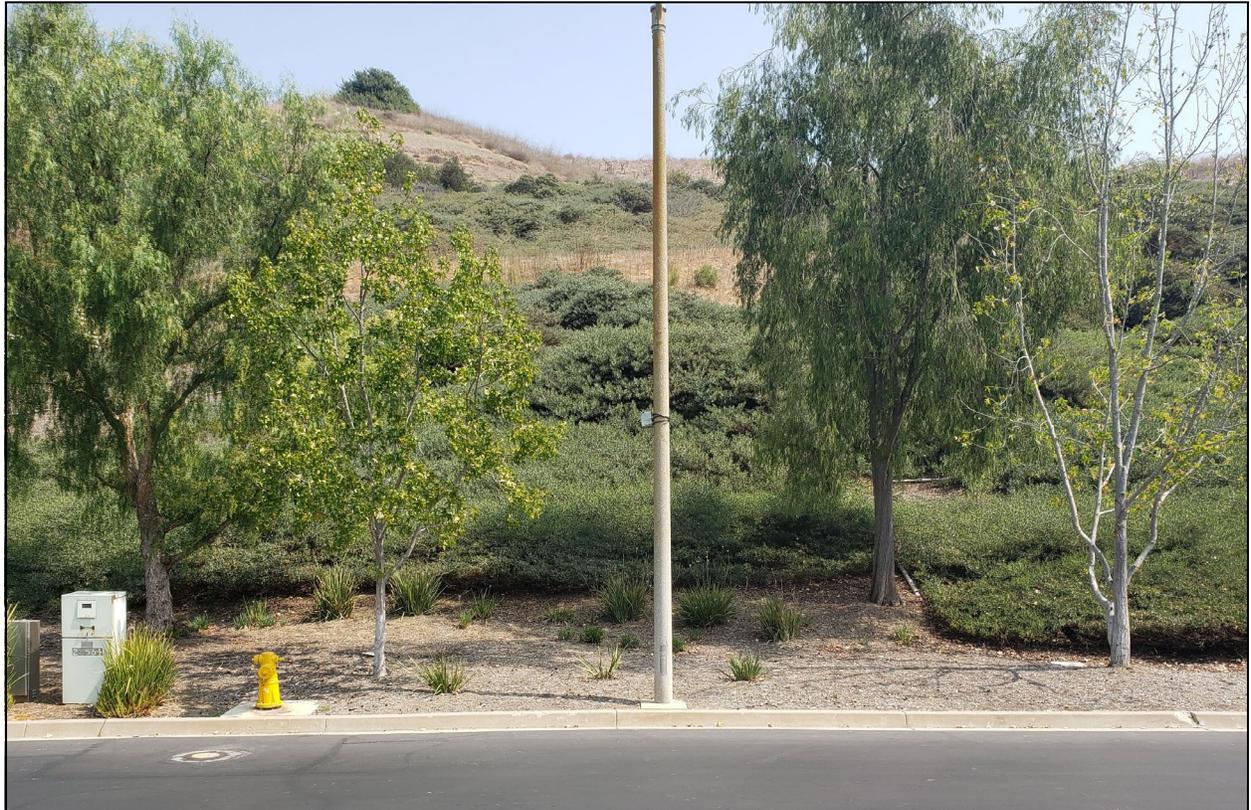
Location Photo:

Site Location: Across the street from 288552 and 28562 Avenida Placida, on light pole.

Primary Noise Sources: Very quiet, HVAC unit running at nearby residence, occasional car driving by on Avenida Placida.

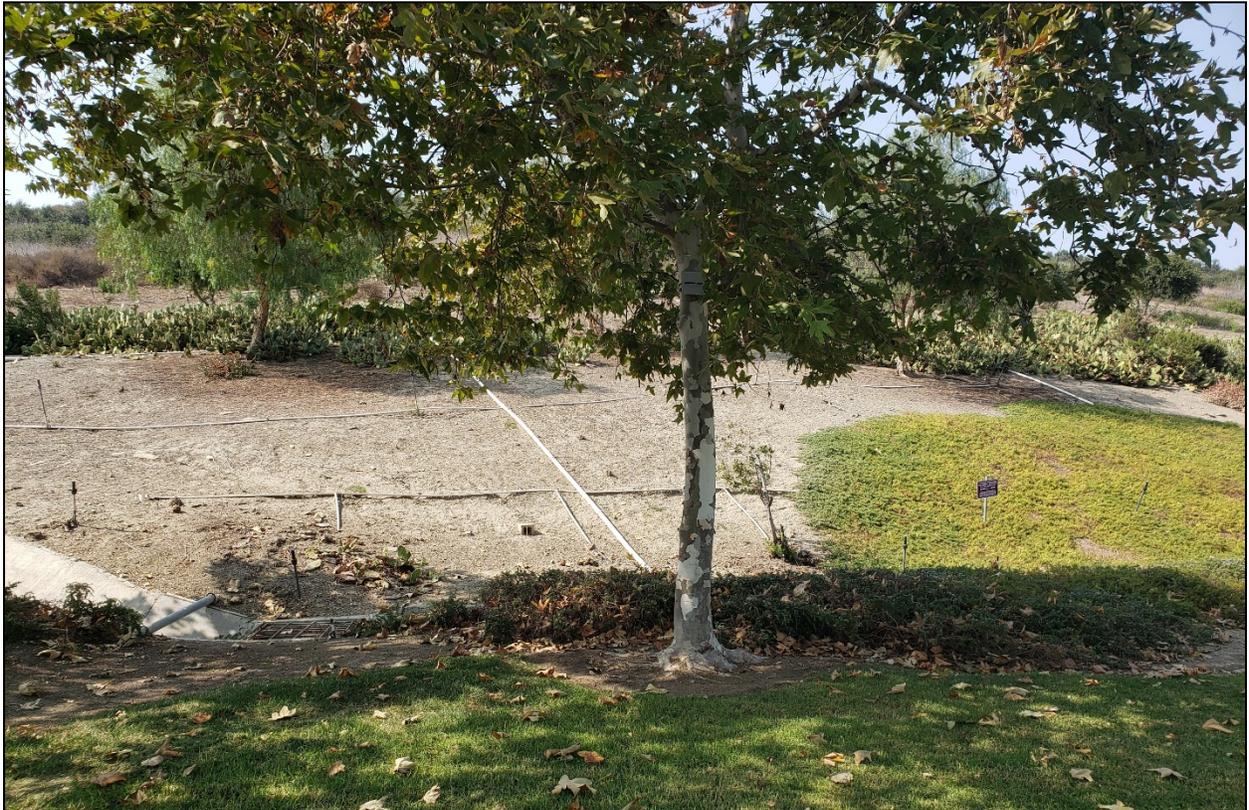
Location Photo:

Site Location: Across the street from 23 Calle Canela, in a tree approximately 30 feet from the curb.

Primary Noise Sources: Very quiet, occasional car driving by on Calle Canela.

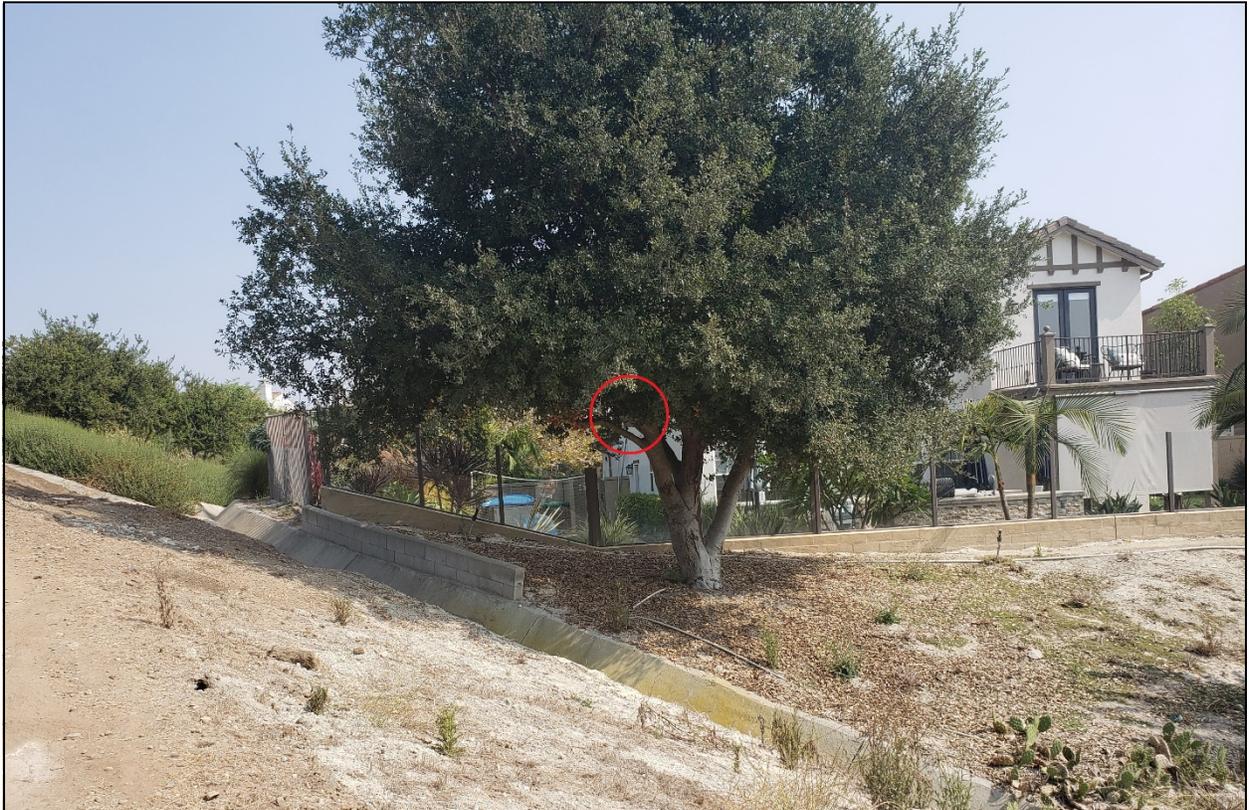
Location Photo:

Site Location: Near the northern corner of 32 Via Balcon, in a tree.

Primary Noise Sources: Very quiet, a few vehicles driving on Via Balcon.
